SAFETY ALERT

Fall from a Ladder

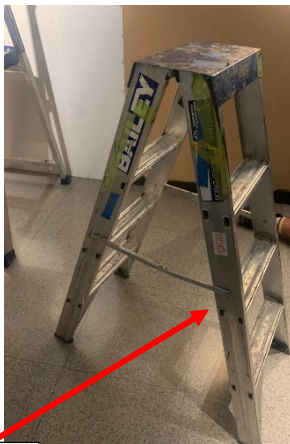
Our staff member placed one foot on the first rung of a step ladder and the other foot onto the second rung and commenced drilling through the MDF into the brick wall, when the drill bit sunk suddenly into the cavity of the brick wall. This caused a change in the staff member's centre of gravity, causing him to fall to the ground, resulting in a dislocated shoulder.

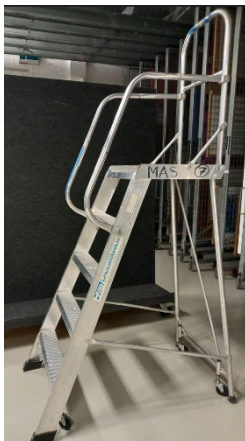
Injured party's foot was on the second rung (575 mm from the ground)

On investigation, the rubber anti-slip end caps on the base of the step ladder were blocked by accumulated debris, reducing its grip on the floor surface.

The sudden change to the staff member's centre of gravity caused the staff member to lose their balance.

- Always assess your Ladder using a pre-start checklist on the Health and Safety [website](#) prior to commencing working on ladders.
- Ensure that the ladder selected is fit for purpose for example, if working at heights, a platform ladder will provide the necessary fall protection hereby reducing the likelihood of a fall occurring. If working on a lower height e.g., less than 600mm off the ground, a safety step stool will prevent overreaching. This stool is also more stable than a step ladder.
- Ensure the completed risk assessment details which ladder is required for the task.
